**Flood Control Project Maintenance  
Levee Inspections**  
**LMA District Cover Sheet**  
**Spring 2017 Levee Inspection Results**

**Reclamation District No. 0524 Middle Roberts Island**

**Spring 2017 Levee Inspection Results**

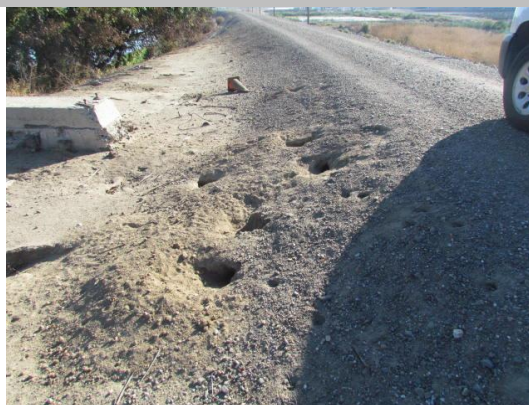
Photo 4 of 4 : SP\_2017\_RD0524\_107\_174\_20170316\_00207.jpg

Looking southeast at several rodent holes on waterward slope. (Fall 2015).

LM Start	0.34	Rating **	M	Issue No.	180
LM End	0.34	Issue Type +	Ma	Location *	WS
Category	Earthen Levee			GPS Latitude/Longitude	
				Start	End
Item	Erosion / Bank Caving			37.938461 °	37.938461 °
				-121.341626 °	-121.341626 °
DWR ID	DWR_RD0524_01_s_2014_180				
Comment Code					
E2 : Schedule repair of erosion site prior to the next inspection.					
Inspector Comment					
Erosion is located along the lower level of waterward slope.

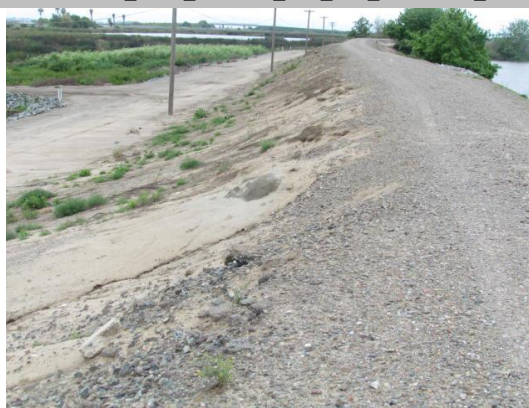
Photo 1 of 2 : SP\_2017\_RD0524\_107\_205\_20170316\_00237.jpg

LM Start	0.40	Rating **	U	Issue No.	205
LM End	0.46	Issue Type +	Ma	Location *	LS
Category	Earthen Levee			GPS Latitude/Longitude	
				Start	End
Item	Erosion / Bank Caving			37.938625 °	37.938695 °
				-121.340479 °	-121.339420 °
DWR ID	DWR_RD0524_01_s_2016_205				
Comment Code					
E2 : Schedule repair of erosion site prior to the next inspection.					
Inspector Comment					
Several damage site within this reach.

Looking at slope damage on landward slope.

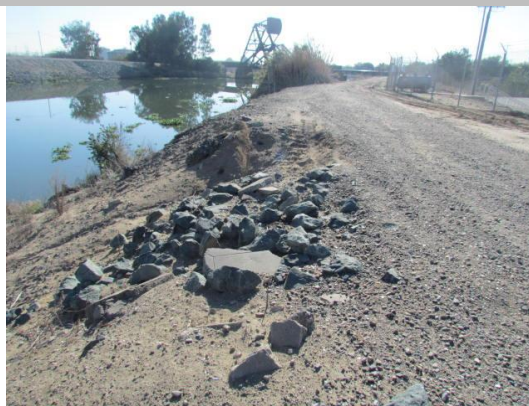
Photo 1 of 4 : SP\_2017\_RD0524\_107\_13\_20170316\_00026.jpg

LM Start	0.64	Rating **	M	Issue No.	13
LM End	0.65	Issue Type +	Ma	Location *	WS
Category	Earthen Levee			GPS Latitude/Longitude	
				Start	End
Item	Slope Stability			37.938105 °	37.938023 °
				-121.336288 °	-121.336173 °
DWR ID	DWR_RD0524_01_s_2012_13				
Comment Code					
S1 : Repair slope instability.					
Inspector Comment					
Depression extend from shoulder to mid levee slope two site with this section.

Looking southeast at depression on waterward shoulder fall 2015

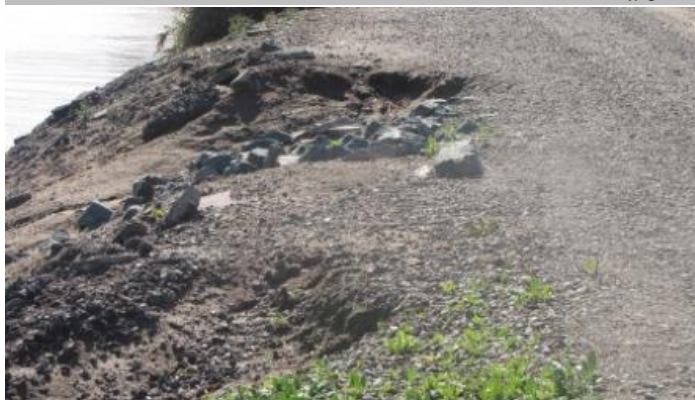
Photo 2 of 4 : SP\_2017\_RD0524\_107\_13\_20170316\_00027.jpg

Looking south at erosion on waterside shoulder.

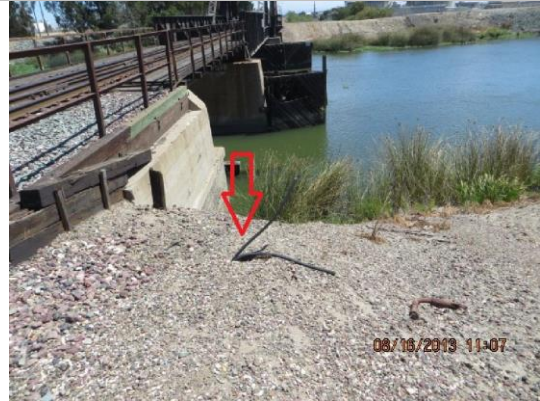
Photo 1 of 1 : UCIP\_SP\_2017\_41463\_29717.jpg

Conduit visible on WS shoulder next to bridge abutment. Cable appears to be abandoned.

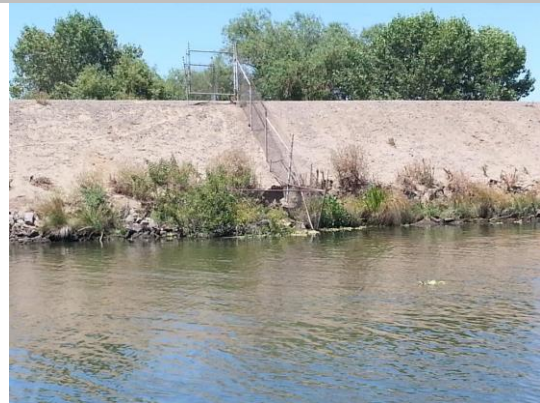
Photo 1 of 2 : SP\_2017\_RD0524\_107\_21\_20170316\_00044.jpg

LM Start	0.76	Rating **	U	Issue No.	21
LM End	0.77	Issue Type +	Ma	Location *	WS
Category	Supplemental			GPS Latitude/Longitude	
				Start	End
Item	DWR Erosion Survey			37.936821 °	37.936821 °
				-121.334582 °	-121.334582 °
DWR ID	DWR_RD0524_01_s_2017_21				
Comment Code					
Inspector Comment					
07/25/2016: No significant change observed.					
06/24/2015: No significant change observed.					
06/19/2014: No significant change observed.					
08/13/2013: No significant change at this site.					
08/07/2012: The site has been visited by boat survey. No significant change observed.					
08/23/2011: The site is located immediately upstream of a Railroad bridge. Dense vegetation at the water line blocks the view of erosion.					
[2016 Site ID:RD0524U01RM41.39]

Front view of the erosion site.

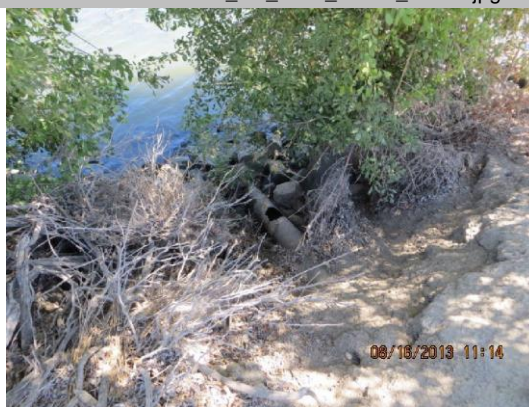
Photo 2 of 2 : UCIP\_SP\_2017\_17571\_29718.jpg

Large hole in pipe at WS toe.

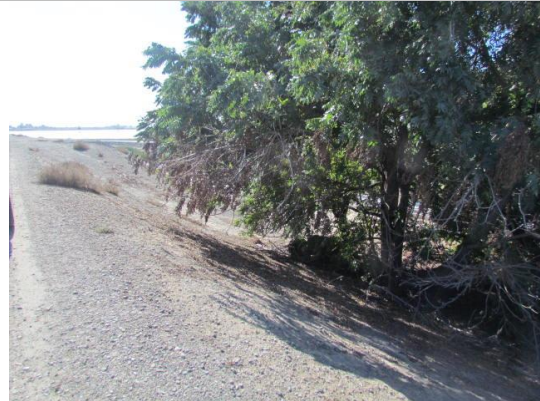
Photo 1 of 1 : SP\_2017\_RD0524\_107\_76\_20170316\_00124.jpg

Looking southwest at low hanging tree branches at landside toe.

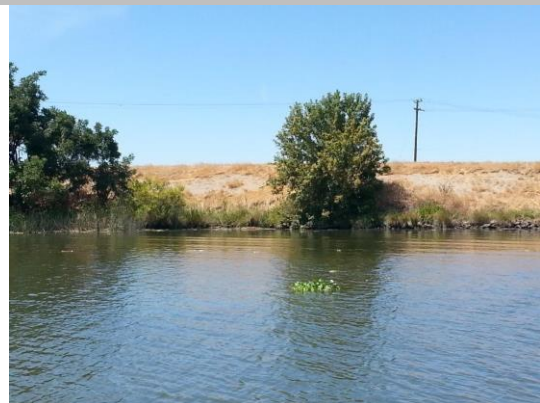
Photo 1 of 2 : SP\_2017\_RD0524\_107\_22\_20170316\_00046.jpg

Close view of the erosion site.

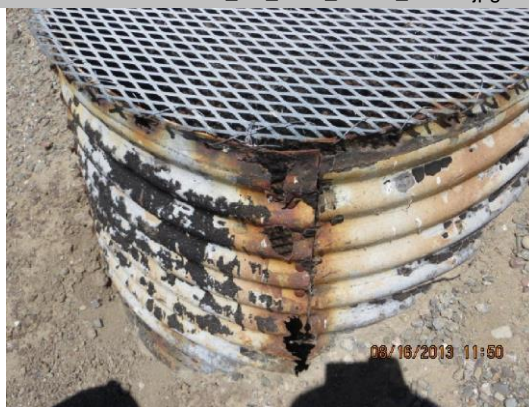
Photo 3 of 3 : UCIP\_SP\_2017\_17589\_29746.jpg

36-inch CMP riser on LS slope severely corroded with various holes along seams.

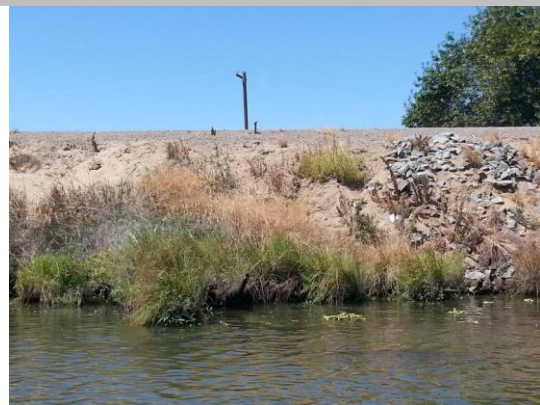
Photo 2 of 3 : SP\_2017\_RD0524\_107\_60\_20170316\_00106.jpg

Close view of the erosion.

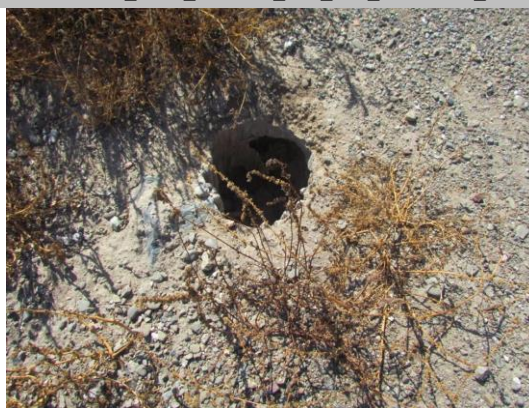
Photo 1 of 2 : SP\_2017\_RD0524\_107\_202\_20170316\_00233.jpg

Looking at hole on waterward shoulder.

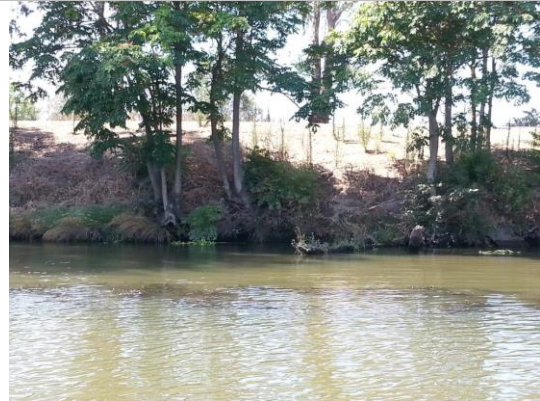
Photo 3 of 3 : SP\_2017\_RD0524\_107\_90\_20170316\_00146.jpg

Close view of the erosion at the levee toe.

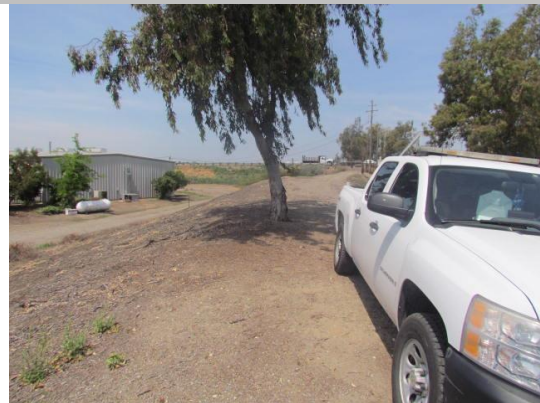
Photo 1 of 1 : SP\_2017\_RD0524\_107\_173\_20170316\_00203.jpg

Looking northwest at tree on within levee crown.

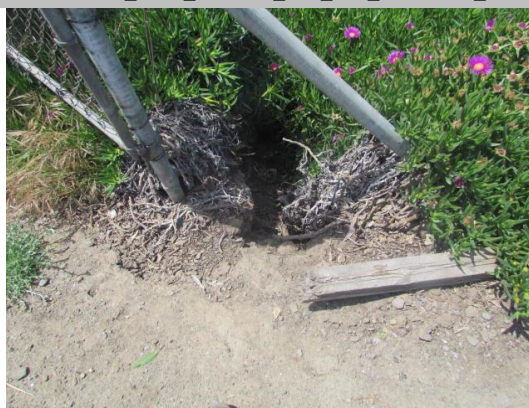
Photo 1 of 2 : SP\_2017\_RD0524\_107\_176\_20170316\_00208.jpg

Looking west at erosion within landscaping on landward shoulder and slope.

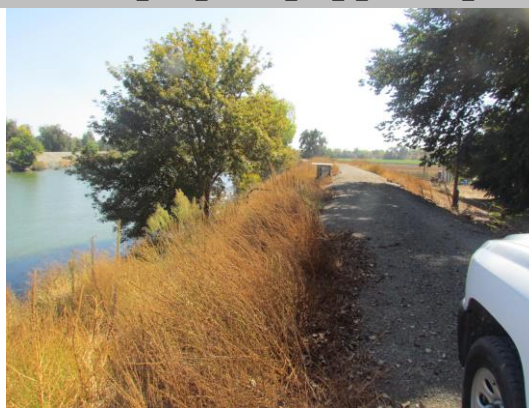
Photo 1 of 1 : SP\_2017\_RD0524\_107\_6\_20170316\_00014.jpg

Looking southeast at dense veg on waterward slope.

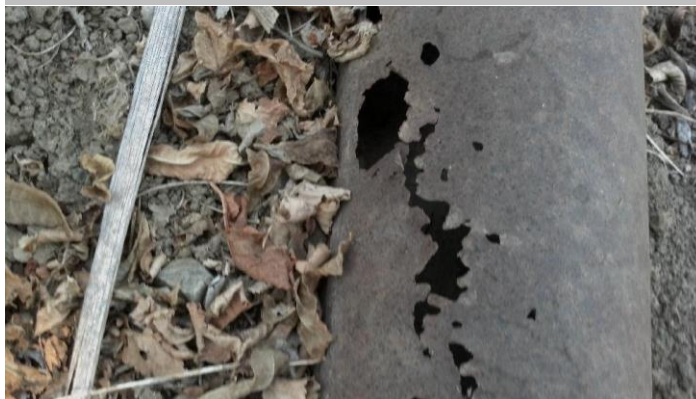
Photo 2 of 2 : UCIP\_SP\_2017\_21883\_37133.jpg

Holes in pipe along exposed side of pipe at WS slope.

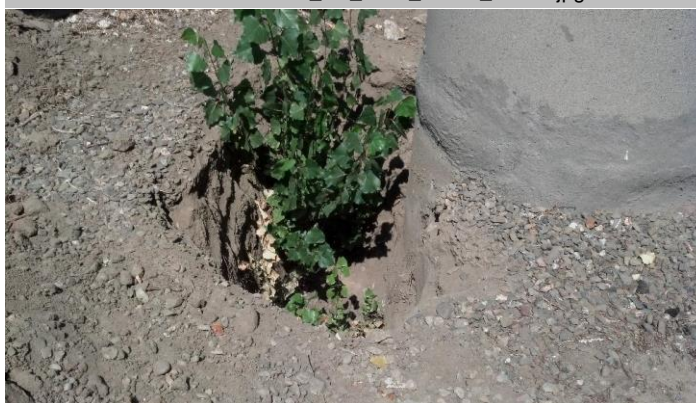
Photo 3 of 3 : UCIP\_SP\_2017\_17944\_30043.jpg

Hole over pipe next to 4-foot diameter concrete standpipe on WS slope.

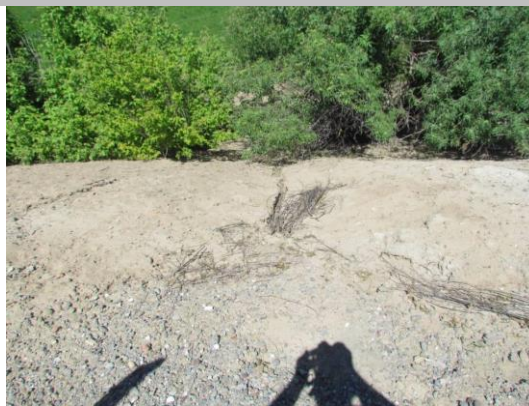
Photo 1 of 1 : SP\_2017\_RD0524\_107\_160\_20170407\_00386.jpg

Looking east at erosion caused by rain runoff on waterward slope.

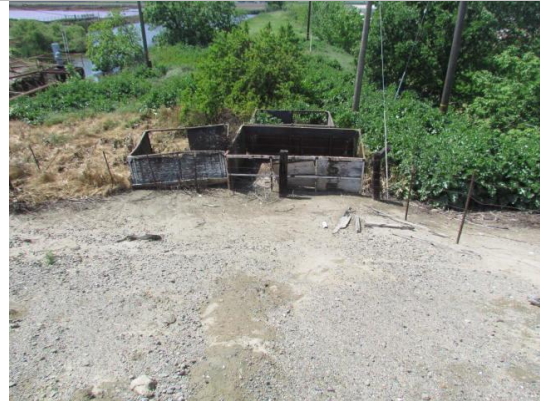
Photo 1 of 1 : SP\_2017\_RD0524\_107\_210\_20170316\_00243.jpg

Looking west at abandoned containers at landward toe.

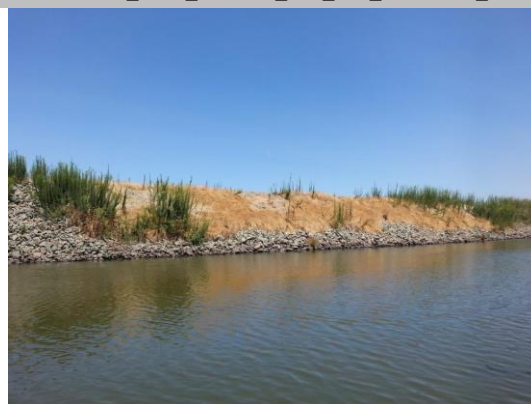
Photo 1 of 2 : SP\_2017\_RD0524\_107\_126\_20170316\_00184.jpg

Upstream view of the erosion.

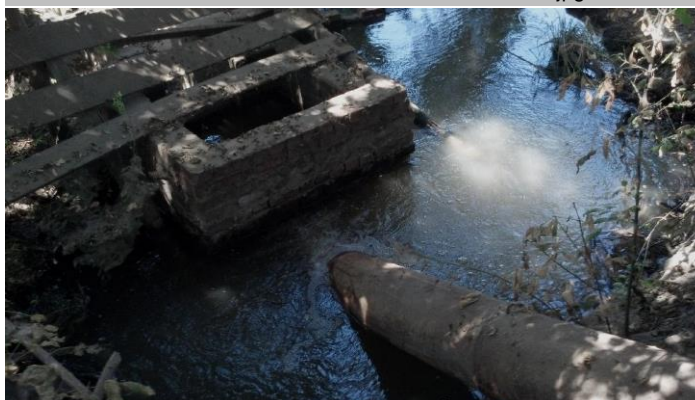
Photo 3 of 3 : UCIP\_SP\_2017\_51320\_30204.jpg

Extensive erosion around distribution box at LS toe.

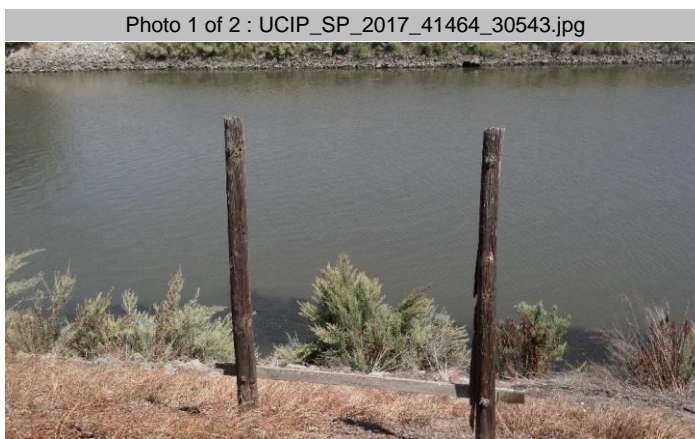
Sign posts with sign removed on WS slope.

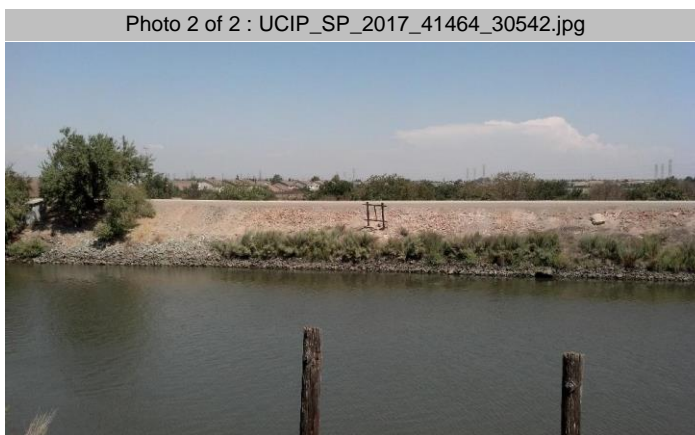
Sign posts visible on opposite river bank in same condition.

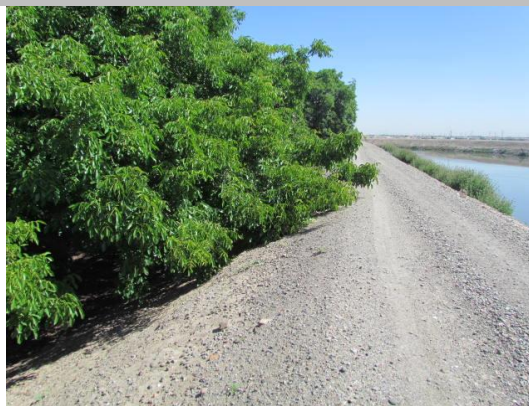
Photo 1 of 1 : SP\_2017\_RD0524\_107\_113\_20170316\_00173.jpg

Looking north at dense trees on landside slope.

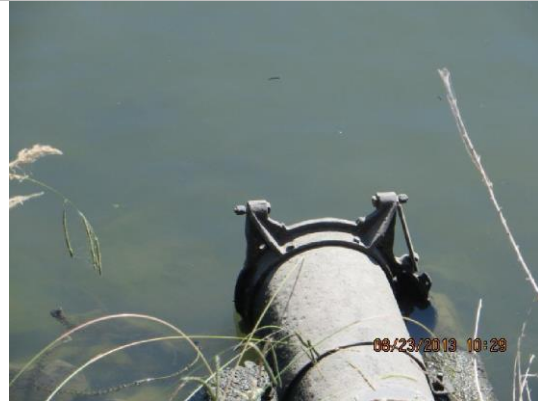
Photo 3 of 3 : UCIP\_SP\_2017\_51633\_30687.jpg

Broken flap gate at WS toe.

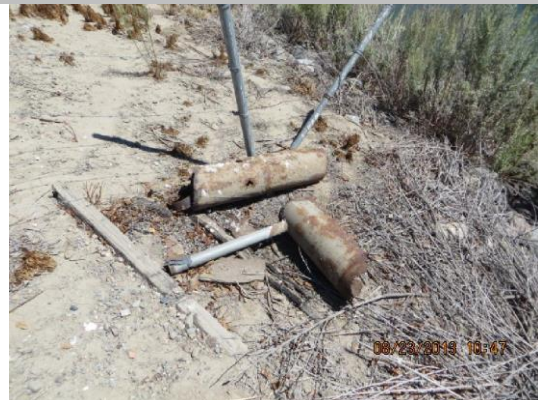
Photo 1 of 3 : UCIP\_SP\_2017\_18348\_30706.jpg

10-inch pipe debris on the WS slope.

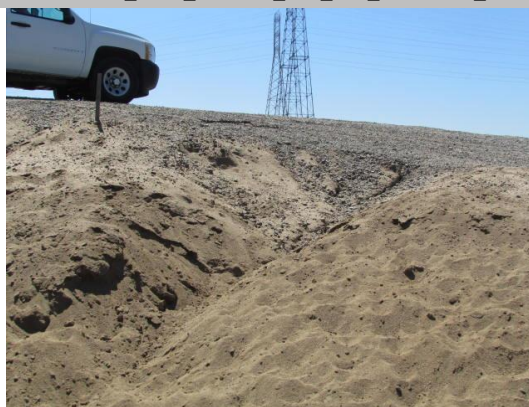
Photo 2 of 3 : SP\_2017\_RD0524\_107\_118\_20170316\_00178.jpg

Looking southeast at damaged slope.

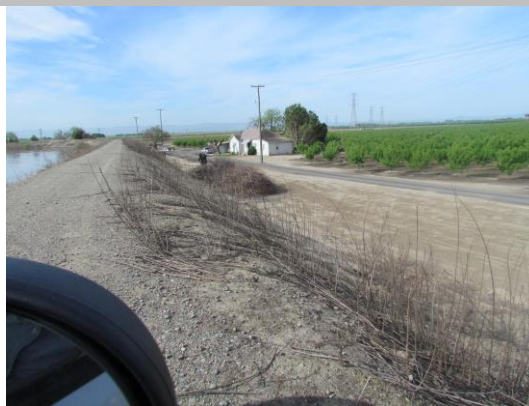
Photo 1 of 1 : SP\_2017\_RD0524\_107\_175\_20170407\_00395.jpg

Looking south at large pruning pile at landward toe.

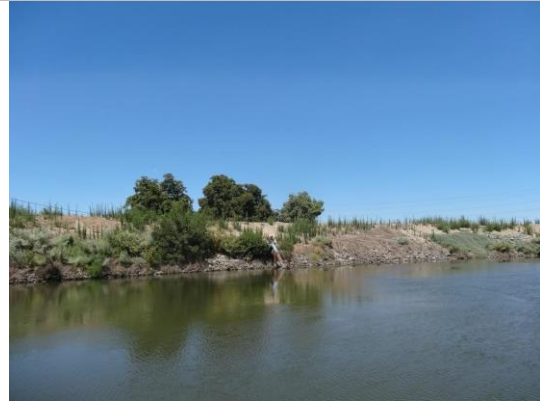
Photo 2 of 2 : SP\_2017\_RD0524\_107\_139\_20170316\_00195.jpg

Upstream view of the erosion and vegetation at the site.

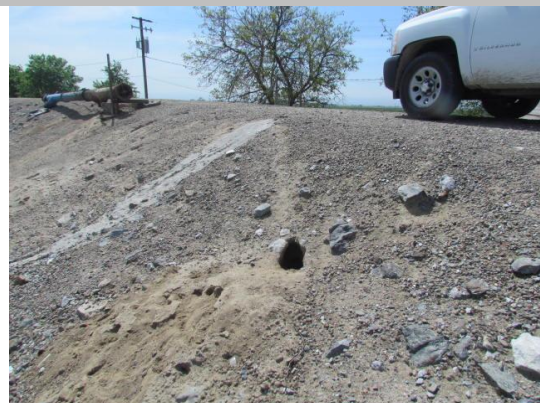
Photo 2 of 2 : SP\_2017\_RD0524\_107\_75\_20170316\_00123.jpg

Looking southwest at typical rodent holes on waterward slope.
